JOINT TASK FORCE ONE

ARMY GROUND GROUP
(TASK GROUP 1.4)

FINAL REPORT

ATOMIC BOMB TESTS

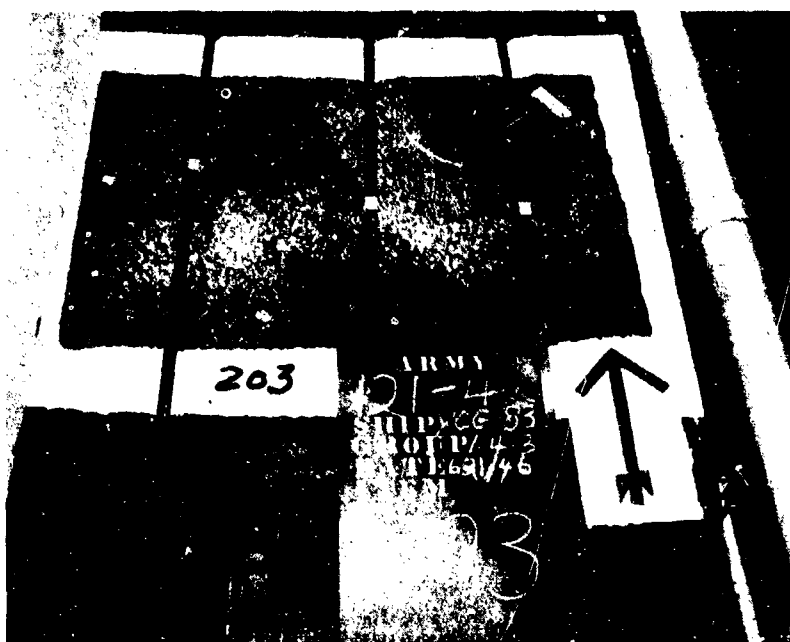
Fig. 471 - YOG 83 - Method of displaying Item 203.

d. Buna N (Butaprene NEM) (Item #203). On the YOG 83, Fig. 471, the sample was blown over the side. On the LST 52, Fig. 472 and Fig. 435, the item was displaced but suffered no damage. There was no apparent change on the remaining three ships.

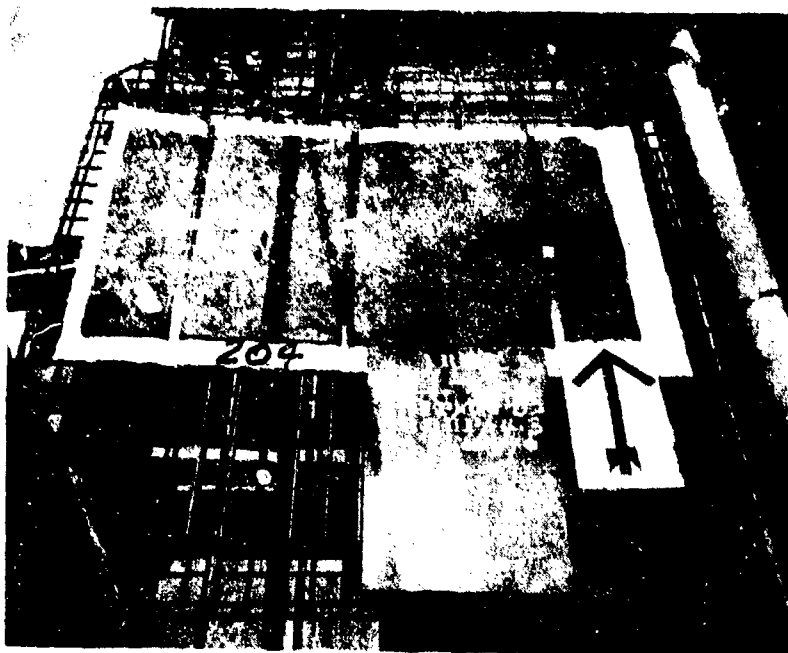
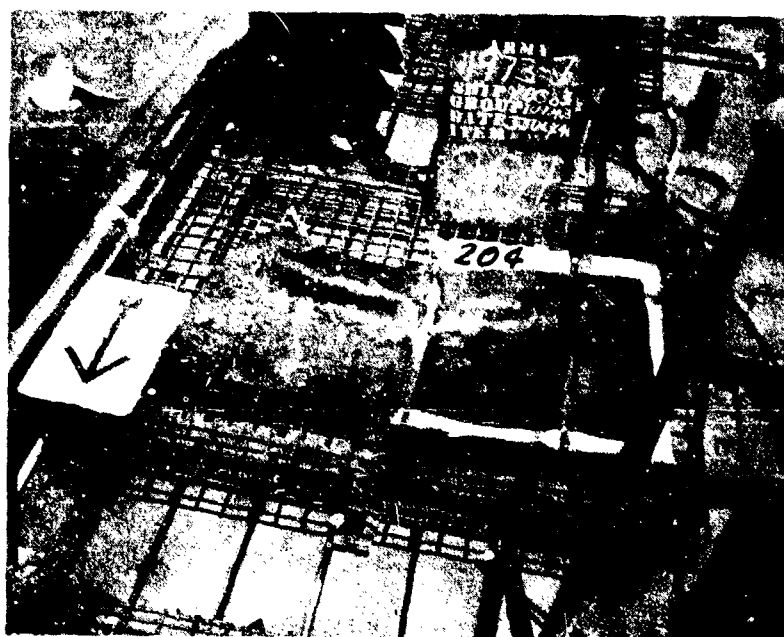
e. Natural Grade Rubber (Item #204). On the YOG 83, Fig. 473 and Fig. 474, the rubber sample was scorched and its painted identification marking was burned off. The sample was curled under the middle strap. One strap

was blown off cutting a 7" slash in the sample. These straps were forced deeply into the rubber. No damage on the other ships was evident.

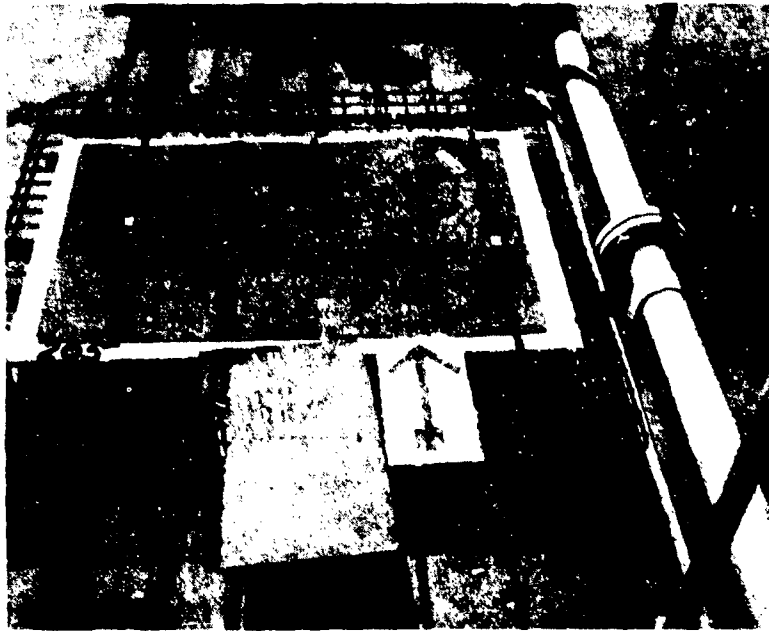
Fig. 475 - YOG 83 - Method of securing Item 205.

f. Black Butyl (Item #205). On the YOG 83, Fig. 475, the item was apparently blown over the side. There was no damage on the other ships.

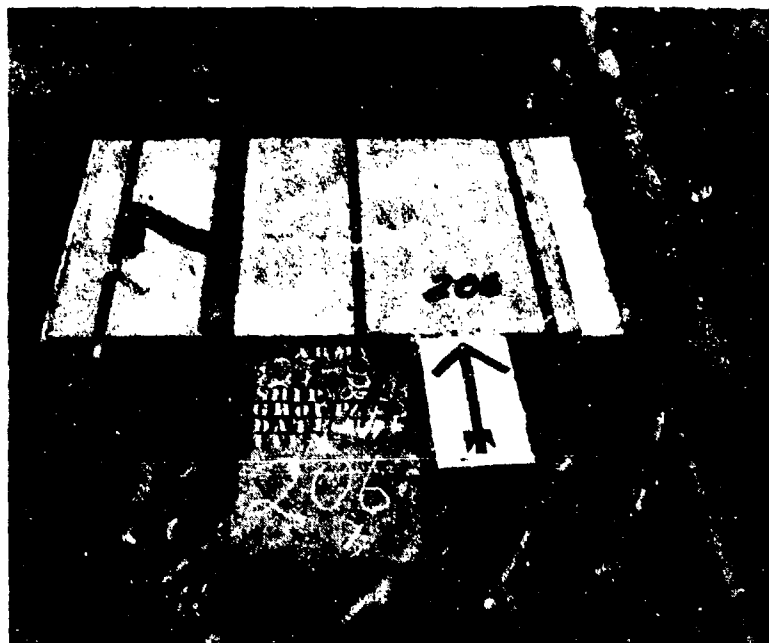
Fig. 476 - YOG 83 - Method of displaying Item 206.

g. White Butyl (Item #206). On the YOG 83, Fig. 476, the sample was blown off the pallet and was slightly scorched. On the LST 52, Fig. 477, the item was not recovered. It is believed to have been blown overboard by the blast. No damage was apparent on the other ships.

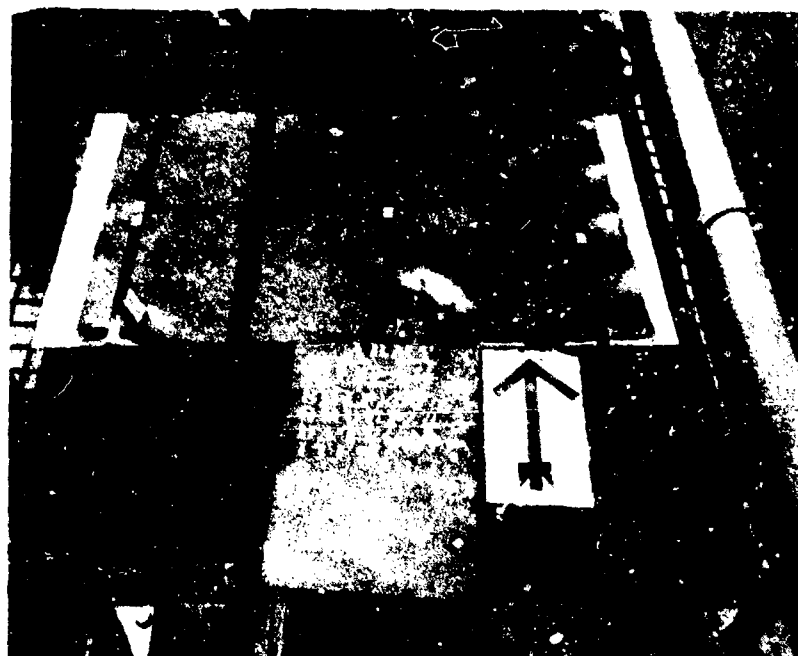
Fig. 478 - YOG 83 - Method of displaying Item 207.

h. Gum Butyl (Item #207). On the YOG 83, Fig. 478, the item was blown off the pallet. It was scorched and some sticky fluid in the rubber had melted and could be seen on the surface. This was black and tended to obscure the original color of the sample. There was no damage on the other ships.

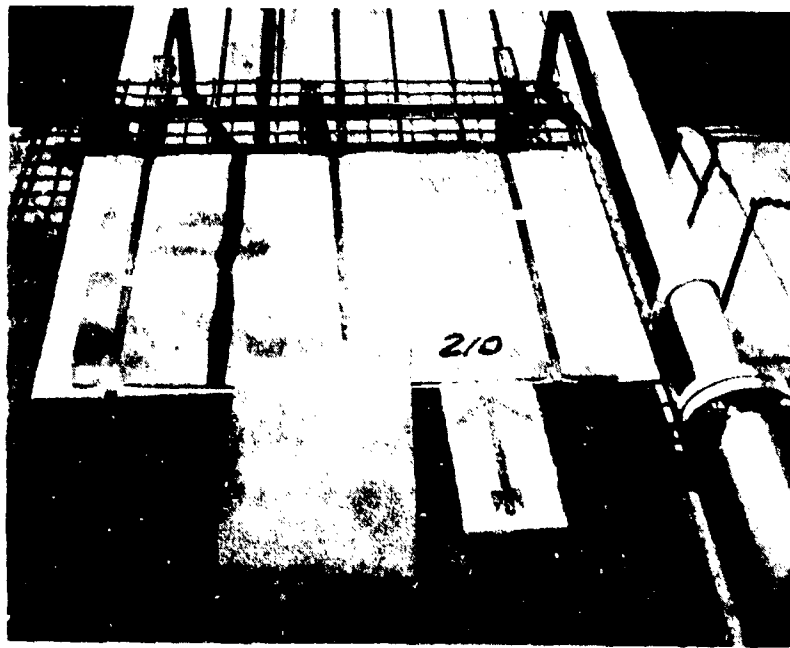
Fig. 481 - YOG 83 - Method of securing Item 210.

k. Gum Perbunan (Item #210). On the YOG 83, Fig. 481, the item was apparently blown over the side. There was no damage on the other ships.

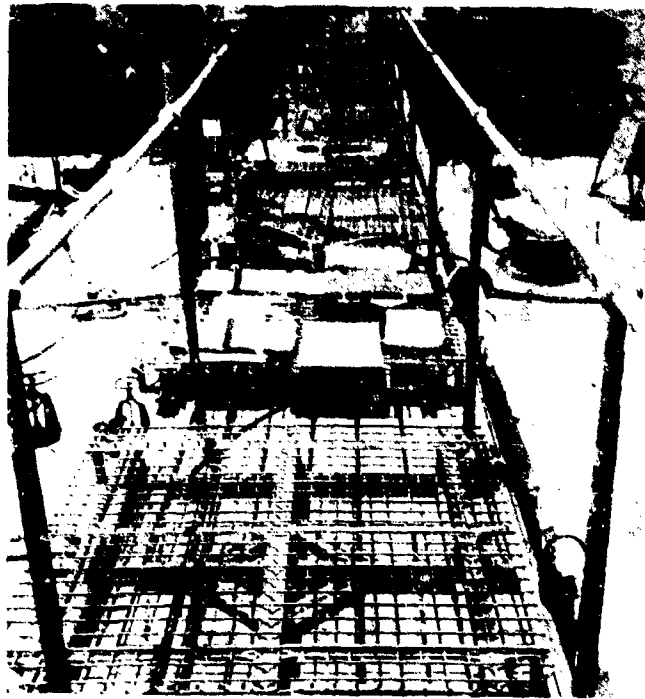
l. See Fig. 482 for overall view of the condition of the rubber samples on the YOG 83.

Fig. 482 - YOG 83 - View after Test Able,
showing the damage to the rubber
samples displayed on the catwalk.
